Reconstruction of a Baroque Open Beam Ceiling Based on Material Analysis

Abstract. Reconstruction of a ceiling in the north-eastern wing of a former water fortress in Jeseník was carried out during the repair of its roof structure and replacement of the roof. The most damaged parts of the bearing ceiling beams were removed and partially replaced with new timber in the 70s of the 20th C. The way the work was carried out corresponded to the methods and approaches of the cultural heritage protection of that time. The replacement of damaged heads of ceiling beams with new timber that was fitted without connection to the original ceiling beams and only simply hanged on a metal girder can be considered highly provisional from the current perspective. That is why the repair of timber structures of the water fortress included also a reconstruction of the original ceiling system. Surveys focusing on the building archaeology and material assessing the condition of the incorporated timber were important for the final design of the repair and the concept of presentation of the Baroque ceilings.

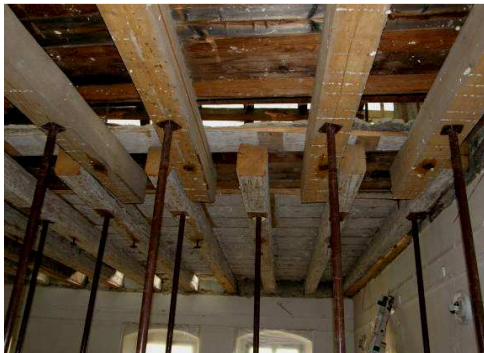
Fig. 2 Parts of ceiling beams inserted during the reconstruction in the 1970s

Building Condition Survey. When the false ceiling was removed, it was found out that 7 out of 14 beams were partially replaced. The remaining beams were original in their entire length. Some beam heads were damaged by brown rot fungi (Fig. 6). The repairs carried out in the past thus not only failed to meet the requirements on high quality and durable repairs but also did not managed to remove or treat all decayed timber. Leaking of rainwater to the attic and the head of wall led to a gradual spread of wood-decaying fungus *Gloeophyllum sepiarium*. The aim of the building condition survey was establishing the extent and degree of damage of the individual ceiling beams.

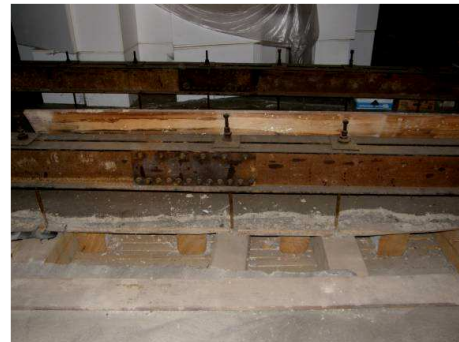
Fig. 3 Steel girders holding the ceiling after the reconstruction in the 1970s

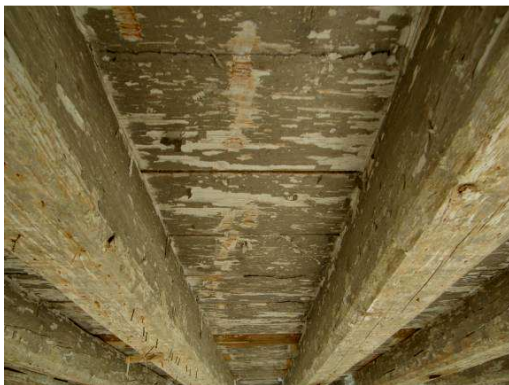
Fig. 4 Remnants of the original surface of ceiling beams after removal of the falls ceiling

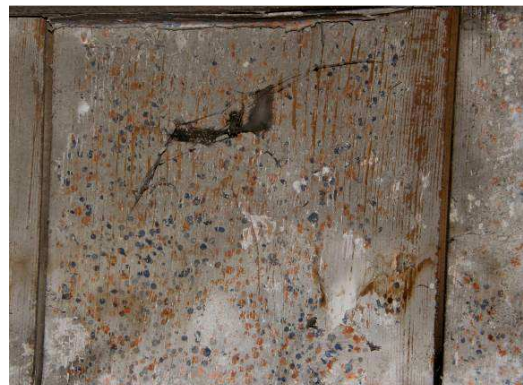
Fig. 5 Detail of the colour decoration on limewash on the decking planks

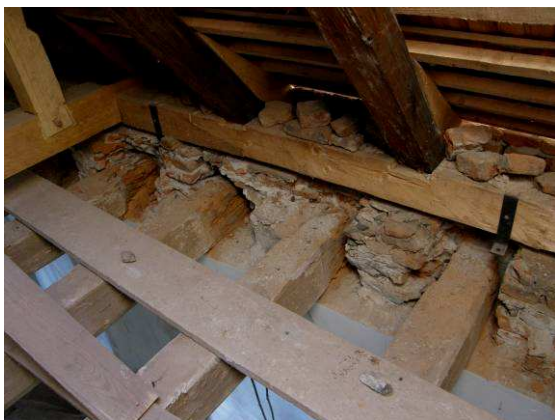
Fig. 6 The beam heads damaged by brown rot fungus

Based on the results of the condition survey the following repair measures for the ceiling were proposed. Removal and replacement of an entire beam was proposed for 2 beams. The first one, build in the wall head along its length, was totally destroyed. The other one had a transversal crack in its lower part (Fig. 7), which was the main reason for its complete removal. Extensions by prostheses were proposed for 12 beams – in two cases these were bilateral prostheses. The remaining 2 beams were left without any structural intervention.

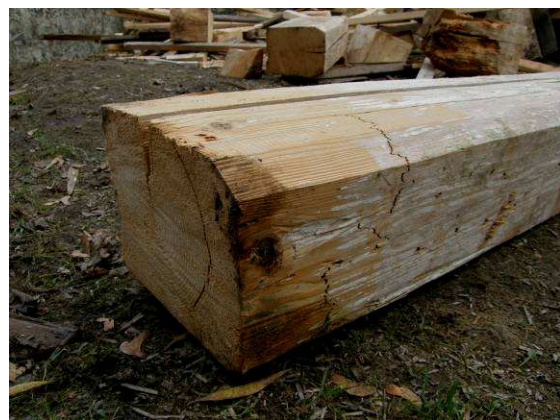
Fig. 7 Detail of the transversal crack in the lower part of beam

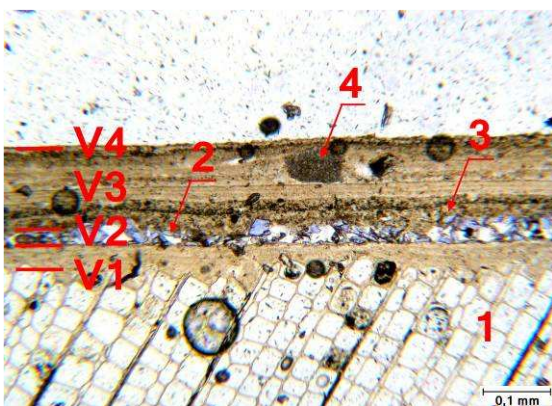
Optical microscopy allowed us to determine the thickness of the layers and to analyse them in more detail (Fig. 8, 9). The samples were used to make transversal cuts through the coating layers and prepare polished thin sections of the material on glued on microscopic slides. The background layer (V1) proved highly adhesive to the wood substrate. This layer was about 0.04 mm thick and it could be considered as one coating although in place it consisted of more layers (brush strokes). The layer with blue pigment consisted of isotropic sharp-angled particles with an average size of 0.02–0.04 mm. The layer with red pigment was thinner and the parts with the pigment formed a homogenous unit through which light did not pass. Above the pigment layer there is a visible coarser-grained zone (about 0.03 mm thick), which probably belongs to the layer V3. Layer V3 consists of more coating layers of the same character and composition. The top grey layer is formed from very gentle particles that could be removed by water – probably dirt. Except for the pigment layer, the other layers contained lime coating without additives. There are minor particles of limestone in places of the lime coating. It probably was the raw material used for the production of lime that was not perfectly burnt or processed. Such a relatively larger particle (about 0.1 mm in diameter) is shown in Fig. 8.

Fig. 8 Cross cut through the coating remnant, 0.24 mm thick. Basic division of the layers for analyses V1-V4. Legend: 1 – wood across the grain, 2 – pigment (crushed glass dyed by cobalt), 3 – a layer of binder over pigments, 4 – limestone particles. Plain polarised light.

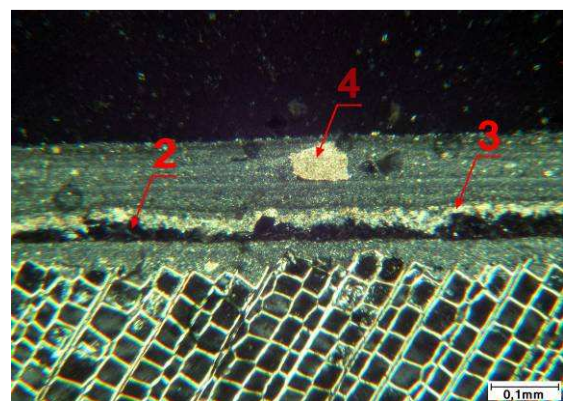
Fig. 9 The cut from fig. 8 in Crossed polarised light (CPL). Legend: 2 – isotropic glass material, appears dark. 3 – the layer over pigments has a different structure in comparison to the rest of the lime coating, 4 – limestone particle.

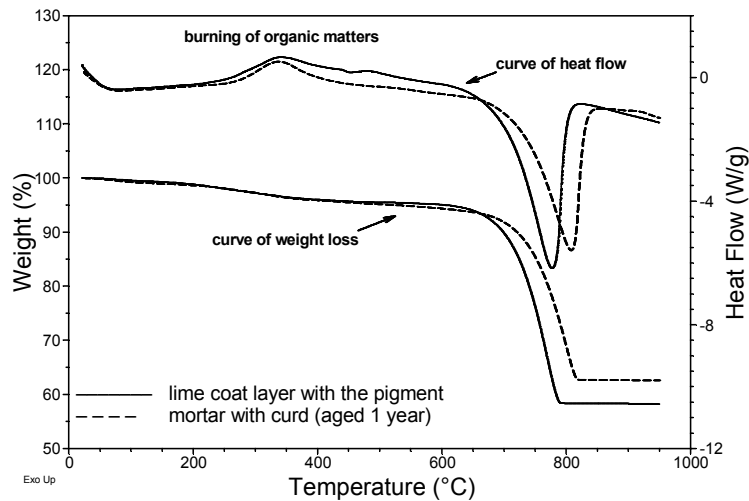
Fig. 10 Output of the thermal analysis of coating layers V3 and V4 with oxygen present. The curve of the heat flow shows an exothermic reaction within heat range of 200–600°C. For comparison there are curves of weight loss and heat flow of a mortar binder sample created from lime with curd (2% of mass for binder).

Thermal analysis and weight loss during the material decomposition show (Tab. 1) that the main component of the coating is calcium carbonate (CaCO_3), which makes about 90% of the lime coating. The weight loss t within the temperatures of 200–600°C corresponds to: (1) natural composition of the raw material – limestone used for lime production (i.e. the lime coating probably contains a small proportion of hydraulic components originating from the reactions of silicon and aluminium oxides during limestone burning), (2) occurrence of organic additives. The curve of the heat flow of the sample from the layers V2 and V3 (Fig. 10) shows an exothermic reaction indicating occurrence of organic additives (burning). However, we cannot identify the compounds corresponding to the weight loss within this heat range based on the thermal analysis only. The weight loss could be caused by other additives (animal hair, etc.) too.

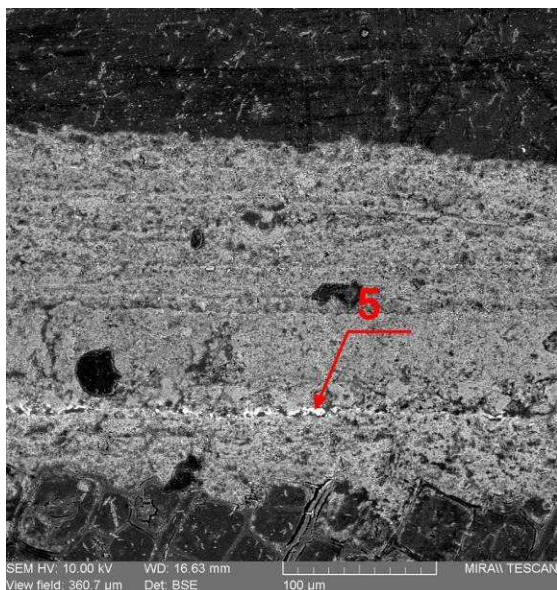
The element analysis of the binder and parts of pigments was conducted using scanning electron microscope (SEM) equipped with EDS analyser. The polished thin sections were gilded and explored in detail in the high vacuum mode. Figs. 11 and 12 show profiles across the coating layers depicted using back-scattered electrons (BSE). The conspicuous white colour (Fig. 11) corresponds to the red pigment and identifies elements with a higher atomic number compared to the surrounding mass. We can also differentiate individual coating layers in the image. Fig. 12 shows the layer with pigments as well as the unburnt limestone particle (Fig. 9).

Fig. 11 Cross profile of coating layers SEM, BSE. Legend: 5 – conspicuous white colour is the red pigment with a higher atomic number compared to surrounding materials.

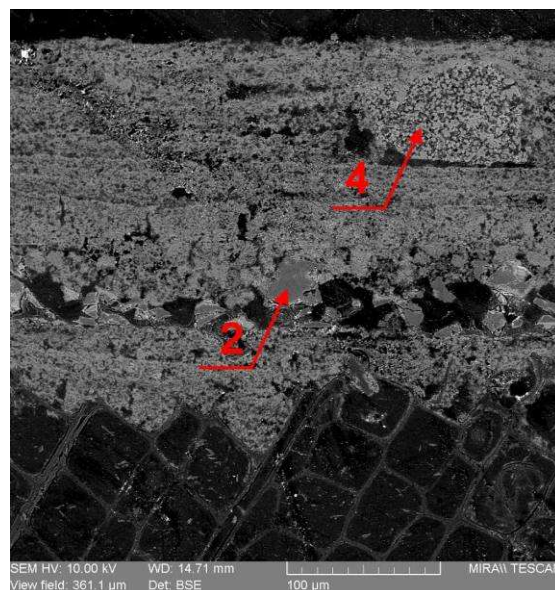
Fig. 12 Cross profile of coating layers SEM, BSE. Legend: 2 – sharp-angle glass particle – blue pigment, 4 – limestone / unburnt limestone particle.
