COST Action FP1101 Assessment, reinforcement and
monitoring of timber structures

**COMBINE USE OF NDT/SDT
METHODS FOR ASSESSMENT OF
STRUCTURAL TIMBER MEMBERS**

Assessment of timber floors by means of non-destructive testing methods

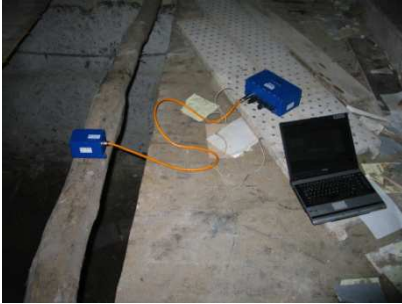
Fig. 1. Frequency measurement on a single timber beam.

For measurements of the ambient vibration of timber floors, seismographs that include tri-axial accelerometers (GeoSIG GSR-18bit), with an acquisition frequency of 250Hz, can be used, resulting in temporal registries of the accelerations to

which the structure is subjected, Fig. 1. The seismographs allow the transference of the information to a computer to be analysed. Nowadays, there are simple electronic devices, such as smart phones, which are equipped with accelerometers and provide reliable results, Fig. 2.

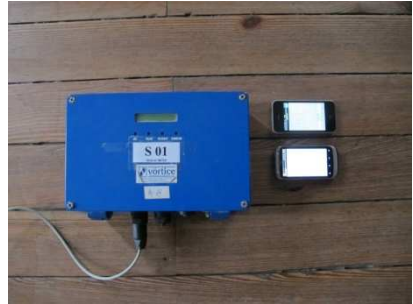
Fig. 2. Calibration of smart phones accelerometers with seismographs.
