COST Action FP1101 Assessment, reinforcement and
monitoring of timber structures

**COMBINE USE OF NDT/SDT
METHODS FOR ASSESSMENT OF
STRUCTURAL TIMBER MEMBERS**

Assessment through NDT of the state of timber structures of the historic buildings of Catalonia

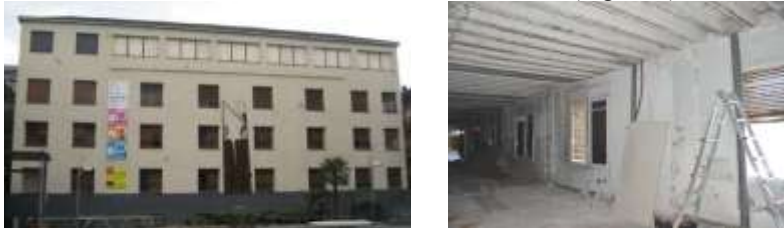
ground floor, first floor, second floor and penthouse floor. Structurally it is built with walls of load and horizontal floors with timber beams (Figure 1).

Fig. 1 Exterior building front view and beams of the second floor

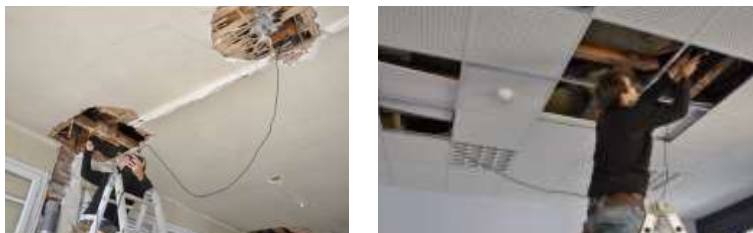
Once the condition of the timber structure was valued positively the assignation of the strength class was performed with the help of the time-of-flight of ultrasonic waves values. Six pieces of timber were analyzed, two bottom chords, which formed the trusses of roof, two beams of penthouse and two beams of the second floor, and in each of them were measured three readings wave speed (Figure 2). The measures were performed on the central part of the timber pieces, with a distance between sensors of approximately two and three meters (Table 2).

Fig. 2 Evaluation of the bottom chords of the trusses of roof with the Microsecond timer

These values of time-of-flight of ultrasonic waves were used for determining the dynamic modulus of elasticity and later, with this value, allocate the strength class using the equations of bending strength (MOR) and modulus of elasticity (MOE), published by Íñiguez [8] for Scots pine. The bottom chord obtained a characteristic value of the bending of 23.49 N/mm², of 35.14 N/mm² for the beams of penthouse and of 20.83 N/mm² for the beams of the second floor, assigning them respectively a class C22, C35 and C20, according to the standard EN 338:2010. In return, the elasticity values limited the strength class of the inspected elements, obtaining characteristic values of 7404 N/mm² for the bottom chords, 9403 N/mm² for the beams of penthouse and 6541 N/mm² for the beams of the second floor, assigning them respectively a class C14, C18 and C14 (Table 3).
