COST Action FP1101 Assessment, reinforcement and  
monitoring of timber structures

State of the Art Report  
WG 1 / TG 2

**COMBINE USE OF NDT/SDT  
METHODS FOR ASSESSMENT OF  
STRUCTURAL TIMBER MEMBERS**

# SDT methods as part of a conservation process

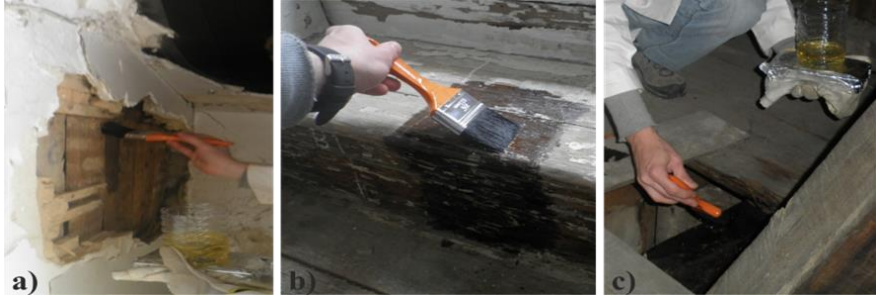
Fig. 1. Application of consolidant a) Wall; b) Staircase; c) Pavement beam 1 [18]

Both products were applied on the timber elements by brush (Fig.1). It is also possible to resort to injections whenever it is justifiable [10].
