Approved Concept for Inspection of Modern and Historic Timber Structures: Theory and Practical Experiences

Frank Rinn

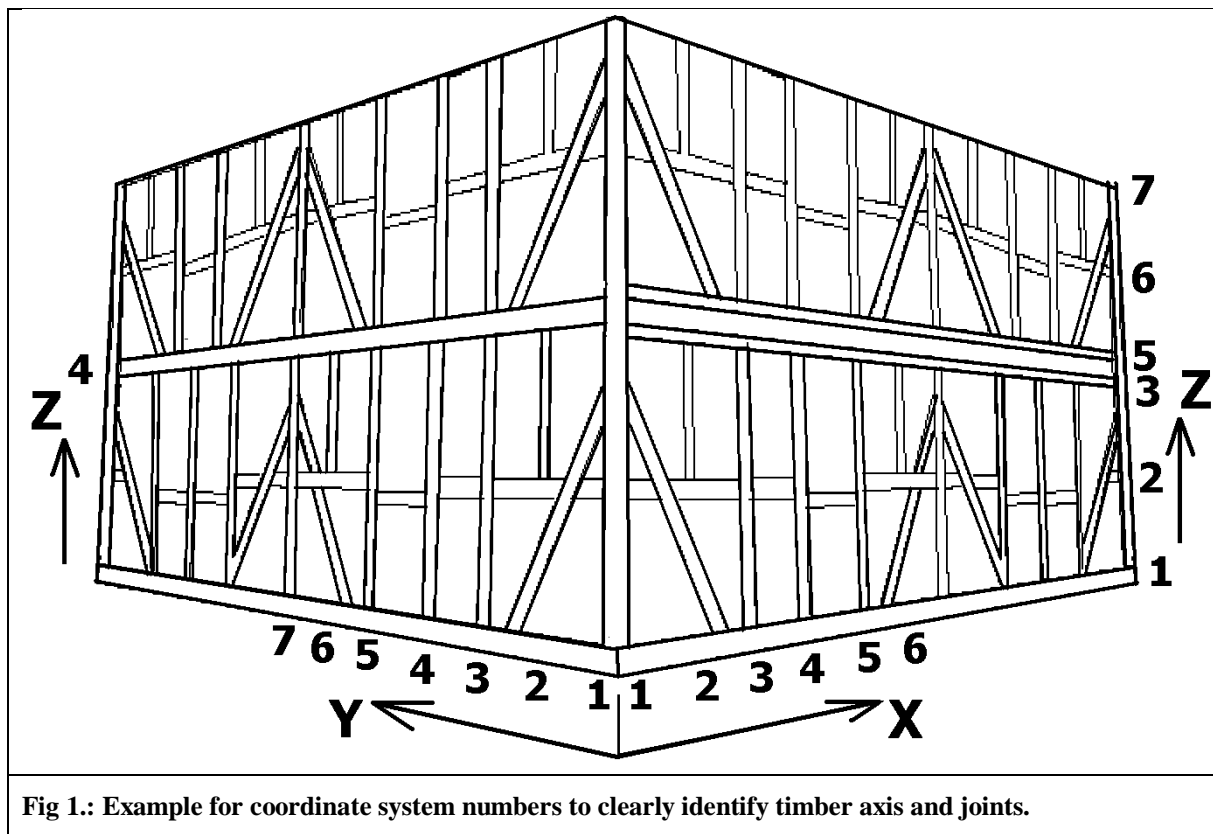
Fig 1.: Example for coordinate system numbers to clearly identify timber axis and joints.

All relevant beams have to be shown in at least one of the sketches. A coordinate system reliably identifies each beam and connection.

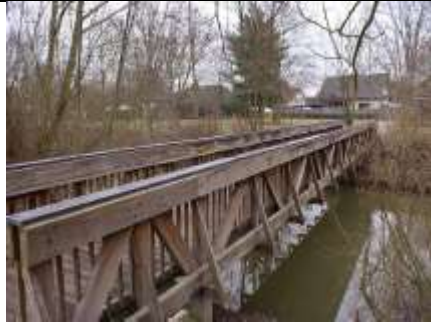
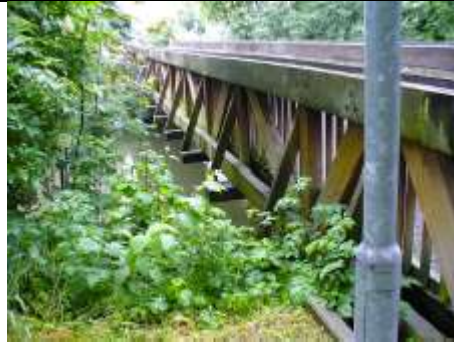
Fig. 5:
 Typical timber bridge to be inspected because of decay (although made by tropical hardwoods).

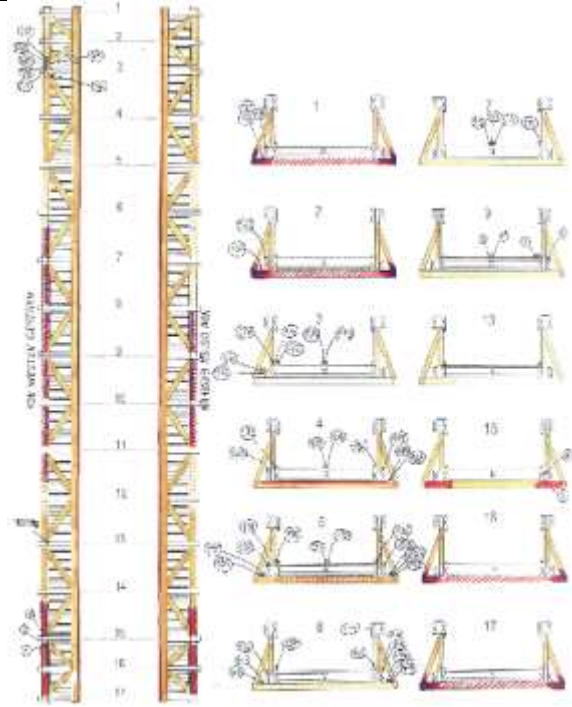
Colored version of an inventory map showing wood condition in different colors. The colors do not only reveal where decay was found but furthermore show what parts of the structure were found and proven to be intact. Because colors allow the reader to much easier identify damaged areas, such a combined sketch replaces many conventional drawings.

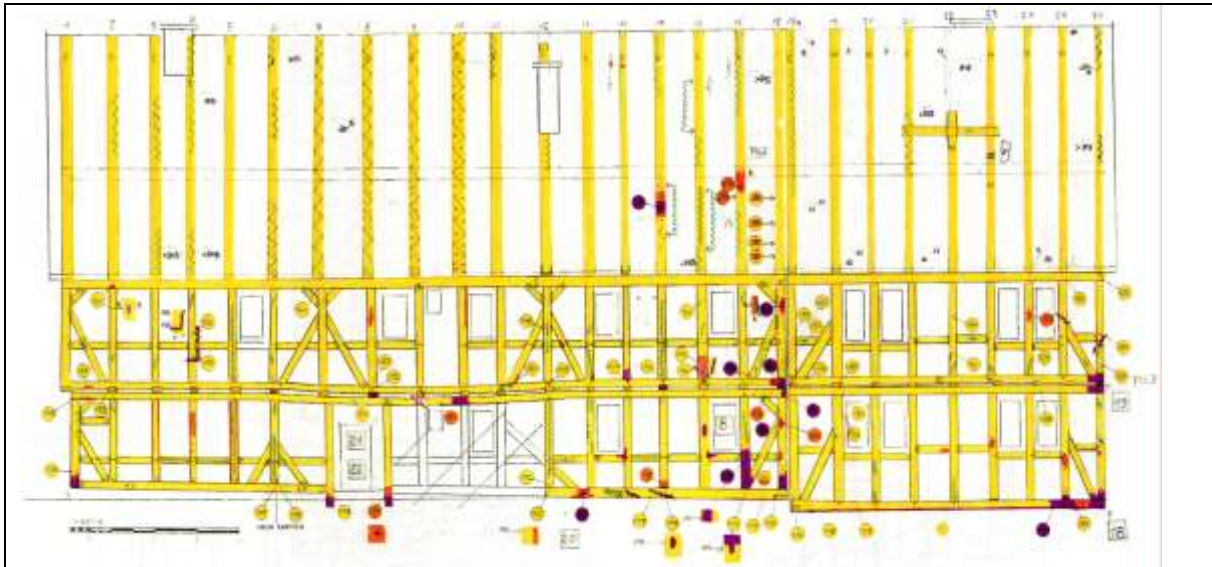
Fig. 6: Example for a simple, combined plan presentation of a half-timbered building. On top of the facade the complete rafter plane of this side is drawn. Such a combination allows for one, the recognition of possible reasons for damage, if, for example, the leaky roof has caused damages to the rafter foot points as well as to the purlin and the post head underneath it in the facade. In individual inventory plans with individual rafter axis and facade drawings, such correlations are often overlooked.

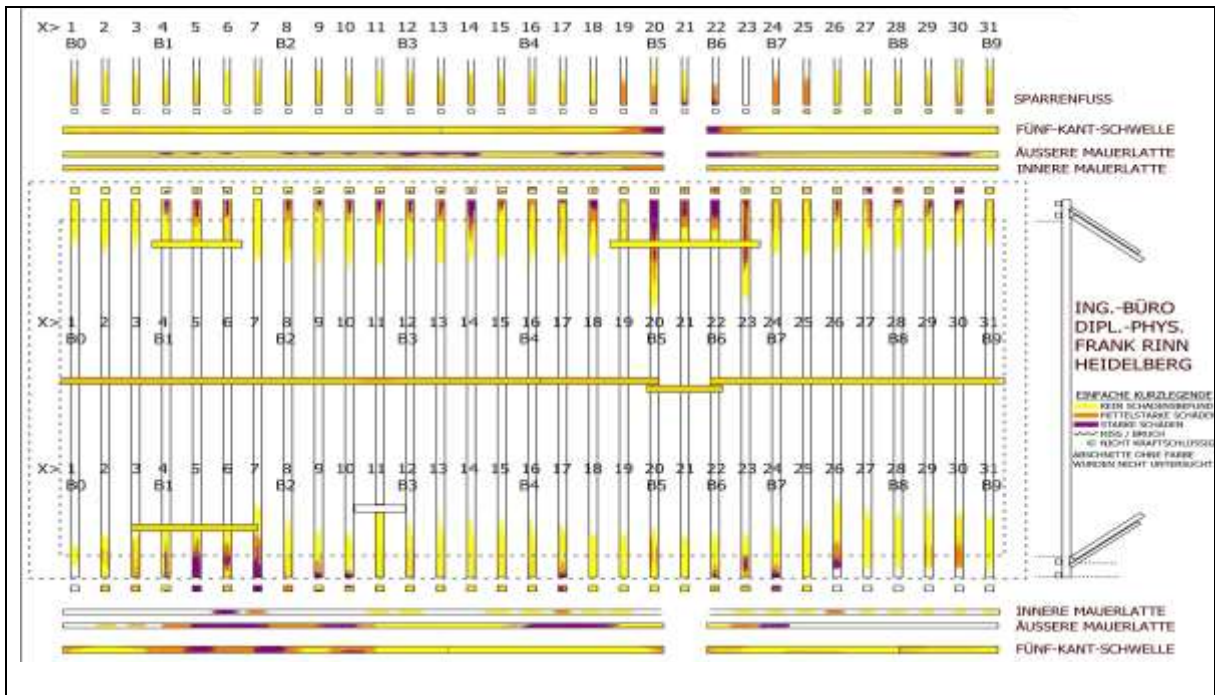
Fig. 8: Ceiling beams of a historic church plus underneath wall beams and the foot parts of looming rafters. This one sketch replaced several dozen sketches of all axes of conventional documentations.
