## Nondestructive Evaluation: Wood

RONALD W. ANTHONY

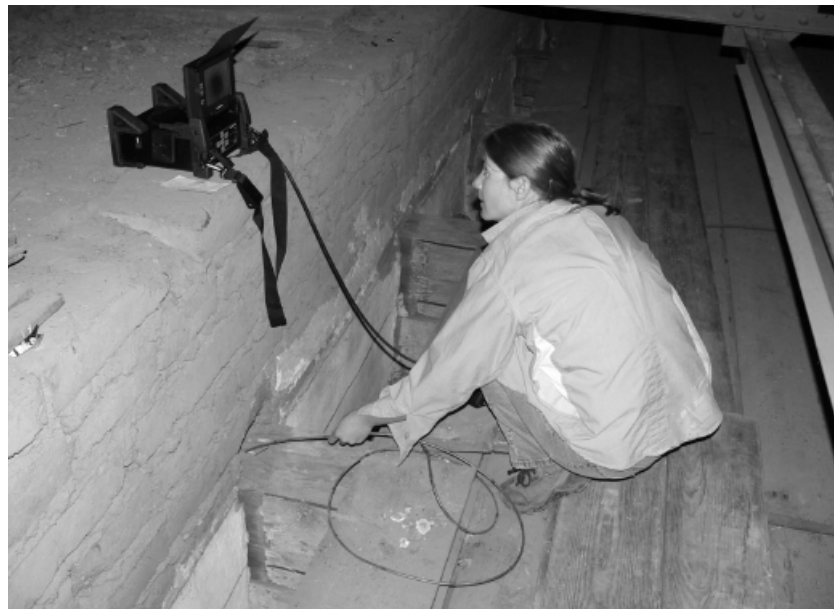
**Fig. 1.** A videoscope being used to inspect the interior of timber embedded in adobe. All images by the author, unless otherwise noted.

transmitted from the camera (borescopes are not discussed here, but information about them can be found in Practice Points Number 9 on nondestructive evaluation of masonry). A portable videoscope camera and insertion tube may be as small as 1/8-inch (3.8 mm) in diameter (Fig. 1). On some models, the camera tip articulates in up to four directions and can have a field of view as large as 120 degrees. The depth of field varies by camera; some models have interchangeable camera tips that allow for a depth of field from 5/32 inch (4 mm) to infinity. Advanced models also have stereoscopic measurement tools for determining distances, lengths, and widths of viewed objects. Most videoscope models allow for capturing still images, and more advanced models can record video (Fig. 2).

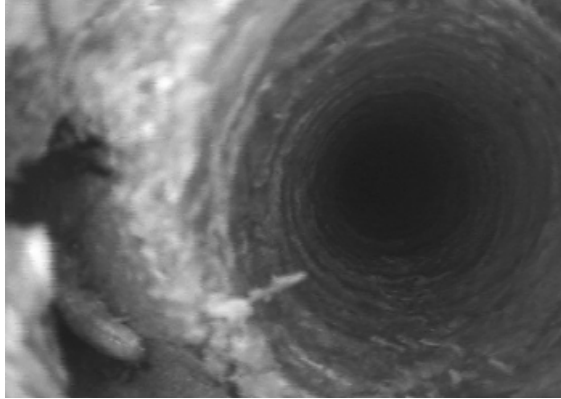
**Fig. 2.**

A videoscope image taken from a bore hole in a timber showing a live termite and internal termite damage on the left.

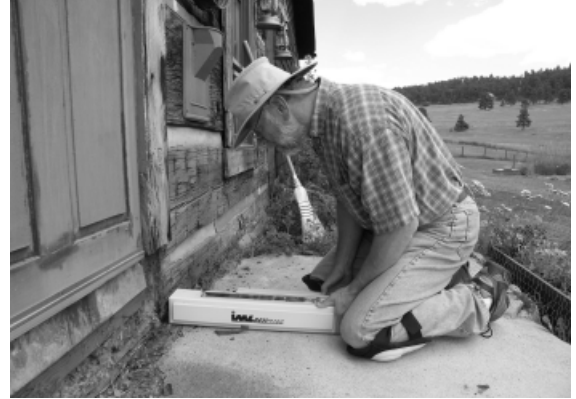
**Fig. 3.**

A resistance drill being used to quantify the extent of decay in a log.

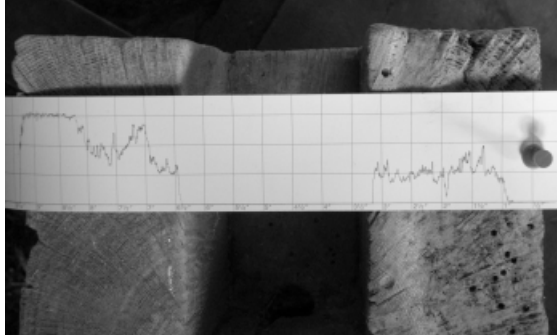
**Fig. 4.** Resistance-drilling print-out against a timber showing (a) insect damage on the right, (b) a void in the center due to construction details, and (c) solid wood that exhibits the effect of growth-ring orientation on the graph.

Due to the ability to measure areas of deterioration and the size of voids directly from the graph, this method is very reliable for quantifying the extent of internal voids due to decay or to wood-boring insects. Resistance drilling removes the subjectivity associated with the need to estimate the amount of resistance encountered when using a hand drill. The equipment is portable and compact enough to allow for investigation of most timbers. In some cases, access to the timber is limited, and drilling must be conducted between timbers or adjacent to the area of interest, such as beam pockets. The drillings can provide a profile of advanced internal decay that is not detectable by simple probing. Originally developed in Europe for inspecting the condition of trees, resistance drilling continues to be used in forestry and has also been used extensively in structure investigations.

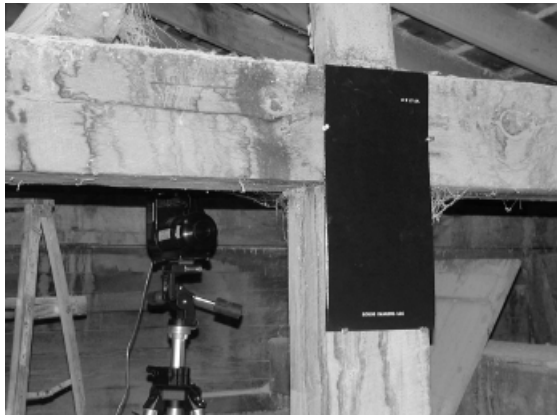
**Fig. 5.** Setup for taking a digital radiograph of a mortise-and-tenon joint in a beam-column connection, with the x-ray source in the background and the imaging plate placed against the column.

**Digital radioscopy.** Digital radioscopy is used to document construction details, help develop a chronology of the construction of a historic structure, and/or identify fastener materials, types, and sizes (Fig. 5). Digital radioscopy can also identify alterations to a historic structure based on construction modifications that are not visible, as well as provide a means to evaluate interior wood condition.

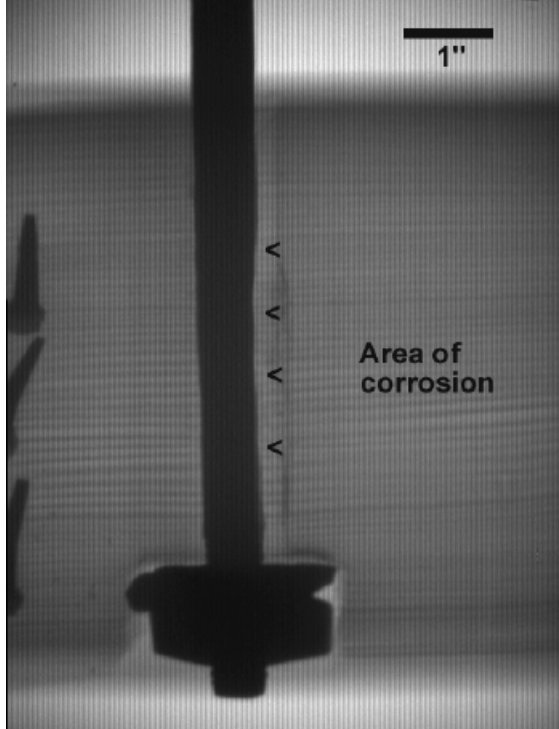
**Fig. 6.**  
Radiograph showing surface corrosion of a wrought-iron rod embedded in a timber beam.

Of equal significance to the historian or architect, and perhaps of greater significance to the structural engineer, is the condition of the fasteners. Corrosion is often hidden within the timber and can lead to catastrophic failure. Digital radioscopy is able not only to detect embedded metal and fasteners but also to show the presence of corrosion of the metal (Fig. 6).

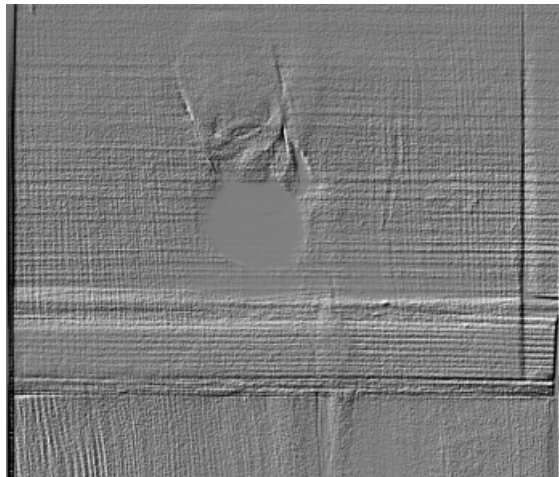
**Fig. 7.**  
Radiograph illustrating post-processing image enhancement to better illustrate the overlapping wood grain of a mortise-and-tenon joint.

For wood connections, such as mortise-and-tenon joints, the interpretation of the radiographs is more challenging. Differences in the grain orientation of the mortise and tenon within a wood joint can be seen on a radiograph when it is possible to place the source and imager perpendicular to the face of the joint. A cross-hatched pattern is typically visible where the two pieces of wood overlap as the tenon penetrates the mortise (Fig. 7).

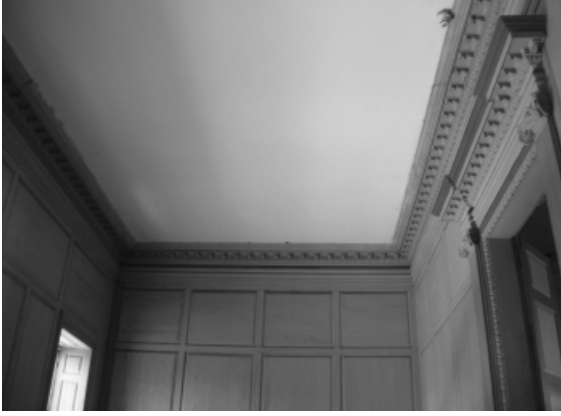
**Fig. 8.** Plaster ceiling with unknown support framing. Courtesy of Jonathan Spodek.

**Infrared thermography.** Infrared thermography can be used to determine some wood construction details, such as wood framing-member locations, when the wood is covered with plaster (Figs. 8 and 9). Although this application of IRT is fairly recent and shows promise, further investigation is needed to better under-

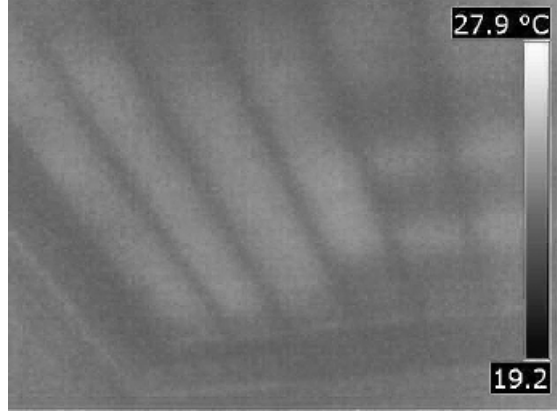
**Fig. 9.** Infrared thermograph of plaster ceiling showing wood support framing above the plaster. Courtesy of Jonathan Spodek.
