## MECHANICAL CHARACTERISTICS OF CHEMICALLY DEGRADED SURFACE LAYERS OF WOOD

**Abstract.** *The aim of this research was to find out whether the effect of chemical corrosion changes mechanical characteristics of surface layers of wooden construction elements. Degradation of the surface layers of wood was caused by chemical reactions of the basic substances of wood mass with compounds contained in antifire coatings. Fire retardants containing corrosive substances were often and repeatedly used in the Czech Republic on many wooden building constructions. This process of chemical corrosion is in practise called as “surface defibering of wood”.*

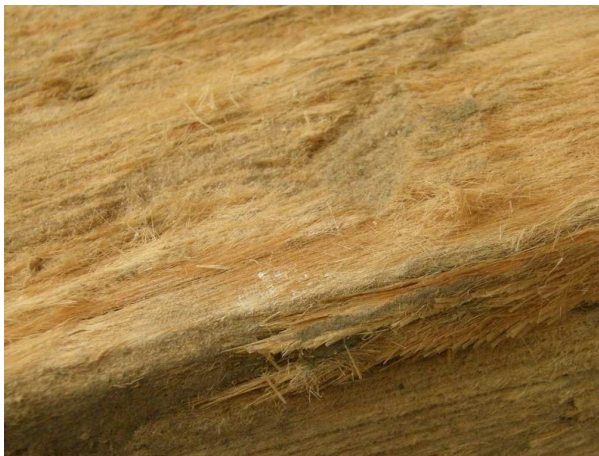
Figure 1: Defibered surface of the construction element

By research of building constructions treated in the past, it was found out that some chemicals contained in the applied agents cause chemical reactions that damage wood polymers – cellulose, hemicellulose and lignin. Application of fire retardants based on ammonium sulphate and ammonium phosphate, e.g. in brewery in Děčín can be mentioned as an example. Application of agents containing these substances caused damage to the surface layers of wood, commonly called as “surface defibering” (Figure 1).

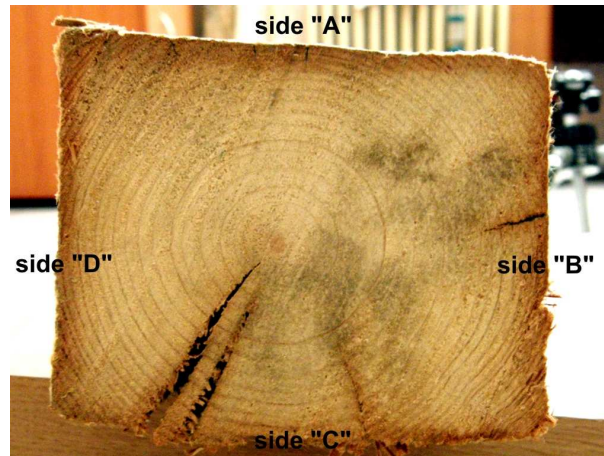
Figure 2: Cross-section of the construction element

Experimental specimens were made of spruce (*Picea abies* (L.) Karst.) collar beam from malt house roof construction of the former brewery in Děčín. Mechanical tests (compression strength, tension strength, bending strength, hardness and impact resistance) were carried out on specimens prepared from the surface layer of the element, damaged by defibering and compared to reference samples made from the inner (non-damaged) part. Preparation of specimens was carried out in accordance with the scheme (Figure 3), which corresponds to cross-section of a girder (Figure 2).

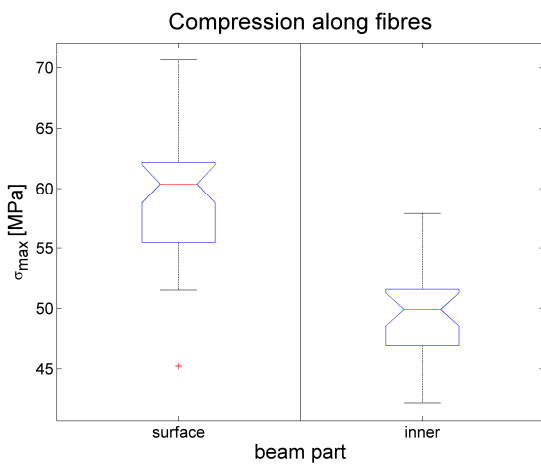
Figure 4: Compression strength along fibres for the surface and the inner part (20×10×30 mm)

Limit of compression along fibres and modulus of compression along fibres were higher for specimens from the surface part of wood than for the specimens from the inner part of wood (Figure 4, 5). We attribute this result to higher density of the surface layer of wood (layer 0-10 mm), which contained narrow annual rings, in contrast to the inner part (layer 15-25 mm) where the annual rings were wider. The difference in density is caused by decrease of average annual ring width along the trunk radius and by increase of percental representation of summer wood in particular annual rings (Gryc and Holan, 2004).

Wood structure had, in our case, more significant effect on the given mechanical characteristics than the defibering of the surface of the element. This fact proves the conformity of the measured mechanical characteristics values (Fig. 4,5) with wood density (Figure 6). Compression strength along fibres was related with wood density, which is confirmed by the determination coefficient  $R^2 = 0,717$  (Figure 7).

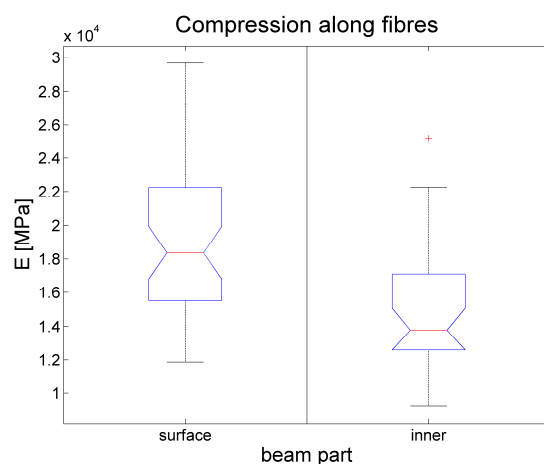
Figure 5: Modulus of compression for the surface and the inner part (20×10×30 mm)

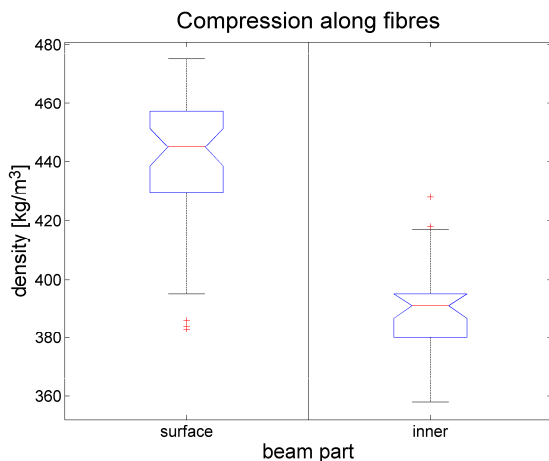
Figure 6: Density of specimens for the surface and the inner parts (20×10×30 mm)

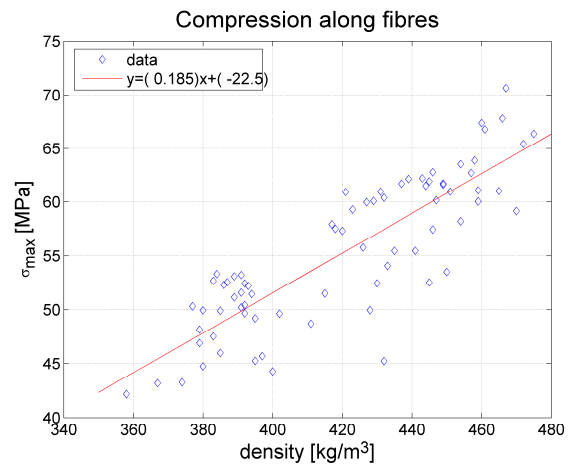
Figure 7: Dependence of compression strength along fibres on density for all specimens (20×10×30 mm)

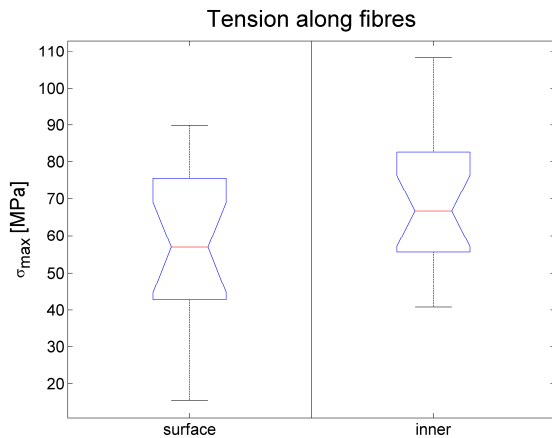
Figure 8: Tension strength along fibres for the surface and the inner part (5×5×7,5 mm)

The test of wood in tension along fibres showed significant decrease of strength in the surface layer of the element caused by degradation of wood mass. The measured strengths of specimens made from the surface parts were 56,3 MPa on average, in spite of their higher density. The strengths of specimens made from the inner part were ca 69,3 MPa (Figure 8), which corresponds to values described in literature for non-damaged spruce wood (Bodig and Jane, 1993).

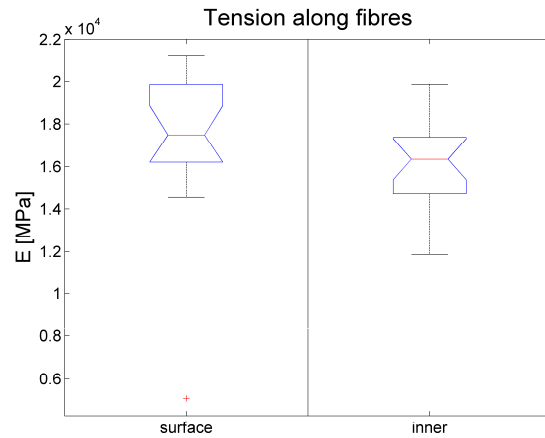
Figure 9: Modulus of elasticity along fibres for the surface and the inner part (5×5×7,5 mm)

The average value of modulus of elasticity in the surface defibered layer was higher by 7,5 % compared to the values of specimens from the inner layer (Figure 9). This result was probably influenced mainly by wood density, low number of annual rings and significant share of spring wood in specimens from the inner part of the element. The reason can be seen in a different mechanism of effect of corrosion on summer and spring wood and in the role of these components for tension along fibres, where the effect of spring wood is very low during tension. Apart from the effect of wood structure and density, it is also necessary to take into consideration high variability of characteristics.

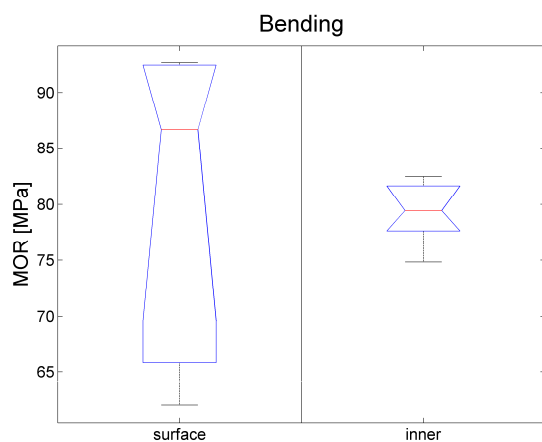
Figure 10: Bending strength for the surface and the inner part (20×10×200 mm)

For bending specimens prepared from the surface part of wood, the average value of bending breaking strength was 81,1 MPa and bending modulus of elasticity was 55611 MPa (Figure 10, 11). For specimens prepared from the inner part, the average value of bending strength was 79,4 MPa and bending modulus of elasticity was 52803 MPa (Figure 10, 11). Values of both characteristics are therefore comparable in both parts of wood. The values measured in the surface part of wood show higher variation. Specimens from the surface part show also significantly higher density (Figure 12). Comparable average values of bending strength and bending modulus of elasticity, in both surface and inner parts of wood, could confirm the effect of defibering that caused the change of mechanical characteristics of wood in the surface layer of the construction element. However, it is necessary to take into account high variation of both characteristics (caused probably by insufficient number of measurements), especially for specimens from the surface parts of the

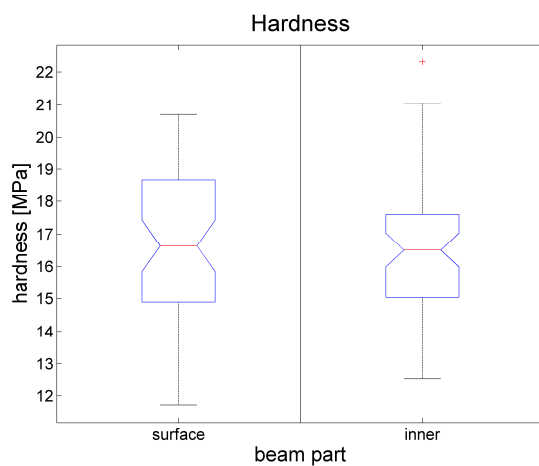
Figure 14: Hardness measured by Janka for the surface and the inner part

Hardness measuring by Janka method describes the change of characteristics in a relatively thin layer of the construction element. The average values of hardness measured were 16,7 MPa in the surface part of wood and 16,6 MPa in the inner part. That means that they are nearly the same (Figure 14). However, due to higher density of the surface layer of wood, this result confirms relative decrease of hardness of the surface of the element caused by its defibering.

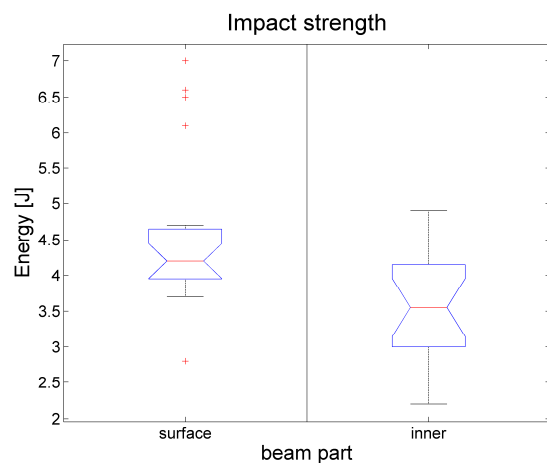
Figure 15: Breaking works for the surface and the inner part (10×7×80 mm)

During the breaking work test, energy required for breaking the specimens with cross-section 10x7 mm (without a notch) was measured. The hammer blow was made in radial direction to the shorter side of the cross-section of testing scantlings. Specimens prepared from the surface layer had higher density and also higher measured impact energy, 4,6 J on average. Specimens prepared from the inner layer of wood had lower density and also lower measured impact energy, 3,6 J on average (Figure 15). Variation of the measured values in the surface layer was significantly lower than in the inner layer; with regard to the difference of densities and impact energies ratio, it is obvious that defibering of wood surface influences its impact strength only minimally.
