## Basics of Wood Inspection: Considerations for Historic Preservation

RONALD W. ANTHONY

*Practice Points* presents basic information on technical topics related to preservation practice as an introduction for those new to the field or as a refresher for more seasoned professionals.

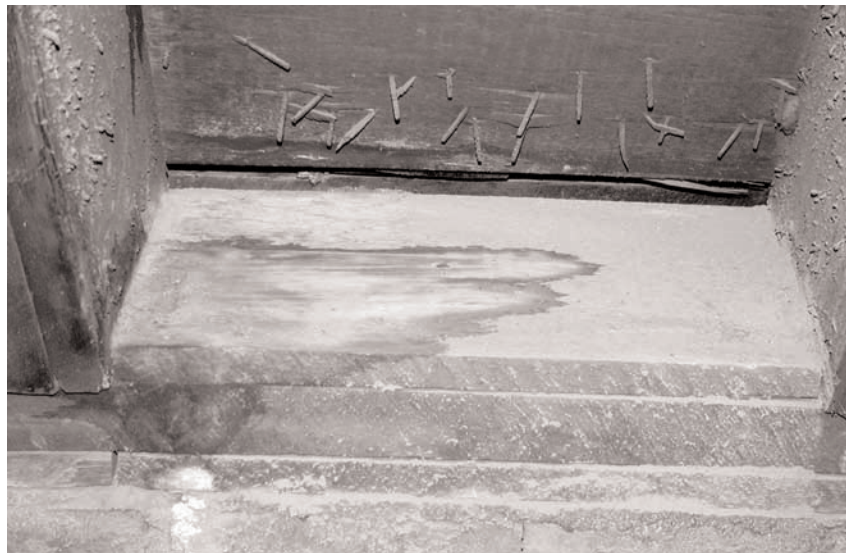
**Fig. 1.** Moisture stain on a sill plate on top of a masonry dome. All photographs by the author.

**Concerns about moisture.** Prolonged exposure to moisture can produce undesirable conditions and long-term maintenance issues for wood in a structure, including moisture stains, peeling paint, and warping of lumber and timber. Stains can be the result of a single wetting or of periodic wetting and drying. A leak that was repaired many years ago may have resulted in a stain that has not affected the wood in any substantive way. Such stains are of no consequence structurally and can be ignored, unless aesthetics warrant a repair. In other cases, stains may be the result of periodic leaks in roofs or walls, which may lead to more serious problems, such as decay or warping. Therefore, it is important to determine whether a stain is the result of an isolated historic event or the result of active leaks and ongoing moisture intrusion (Fig. 1). Decay and insect attack are significant problems associated with periodic leaks or moisture intrusion. Measurements of moisture content can identify wood that has moisture levels favorable for the growth of wood-decay fungi.

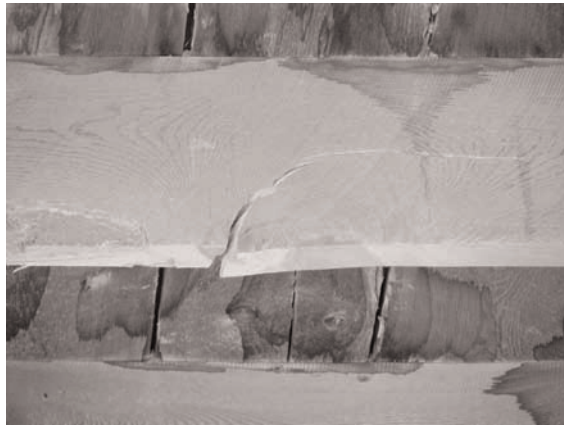
**Fig. 3.**  
Failure of a joist in a silver-mining mill.

**Concerns about deterioration.** Deterioration of wood can be the result of physical processes (weathering, failure due to overload, mechanical damage, or shrinkage) or biological processes (decay and insect attack). Structural timber will typically have checks on one or two faces, which are due to differential shrinkage of the timber and are part of the natural process as the wood dries (Fig. 2). A check is a separation of wood fibers in a piece of lumber, post, or timber, typically along the length of the piece, that results from the drying of the wood after processing or installation in a structure. Checks are not a defect and do not reduce the performance of the piece structurally, unless two checks on opposite faces join to form a through split. However, if the timber has split through the entire thickness, a more detailed investigation is necessary to determine whether the split is a failure resulting from overload or mechanical damage or whether it is associated with shrinkage around connectors (typically bolts) (Figs. 3 and 4). Differential shrinkage in mortise-and-tenon joints can result in failure of the joint that is restricted by the treenail (wooden peg).

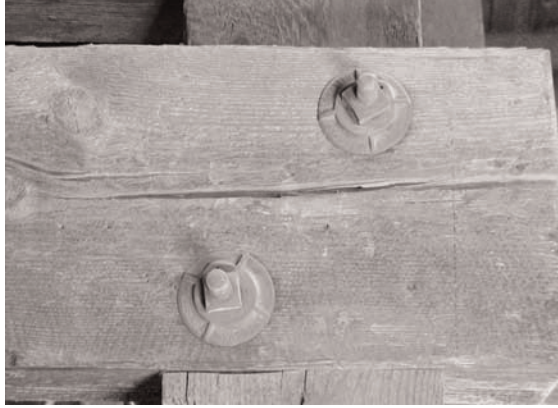
**Fig. 4.**  
*Split between bolts  
caused by wood shrinkage.*

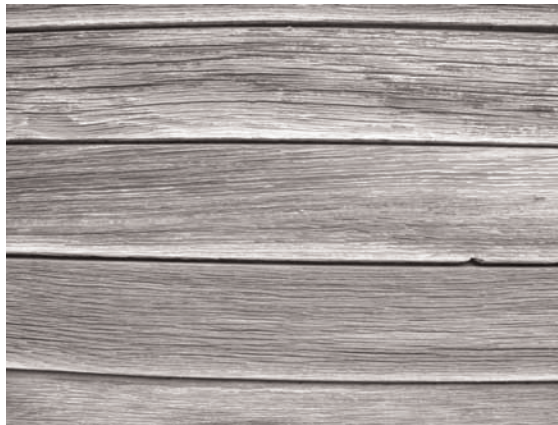
**Fig. 5.**  
*Weathered cladding,  
considered aesthetically  
pleasing.*

Weathering of wood results from cyclic wetting and drying of the wood, exposure to ultraviolet light, and erosion by wind-blown debris, a process similar to sand-blasting. Unlike decay or insect attack, weathering is typically not a significant factor in the failure of wood components and the collapse of a structure. Weathering will change the appearance of wood, but the process is so slow that failure of components due to decay generally occurs long before weathering becomes a major factor in the failure. Weathering seldom damages the wood enough to require replacement, with the exception of shingles and cladding. Weathered wood is often considered aesthetically pleasing (Fig. 5).

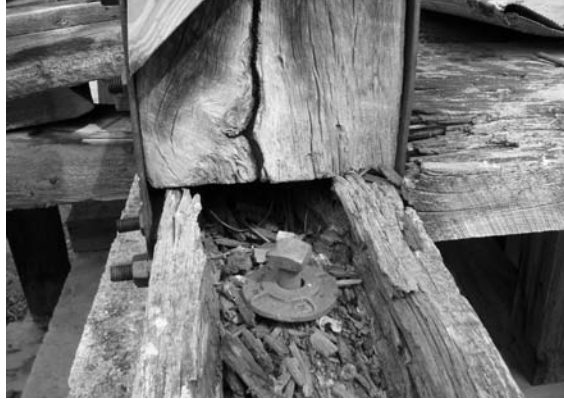
**Fig. 6.**  
*Decayed beam supporting a timber column.*

All wood is subject to a variety of deterioration mechanisms, the most prevalent being wood-decay fungi, which can ultimately lead to the inability of structural members to perform. Depending on wood species, large timbers will retain moisture internally, frequently causing interior rot with no visible sign of the deterioration on the surface of the wood. Moisture absorption through end grain, checks, or holes provides a highly favorable environment for decay fungi to attack the heartwood at the center of a large timber. The heartwood (the inner growth rings of the tree) typically has more decay resistance than the sapwood (the outer growth rings of the tree). However, even the heartwood of naturally durable species such as chestnut will decay when exposed to enough moisture. Deterioration is a particular concern where the wood is in contact with the ground or with other materials, such as porous masonry, that may allow for moisture to be absorbed into the wood.

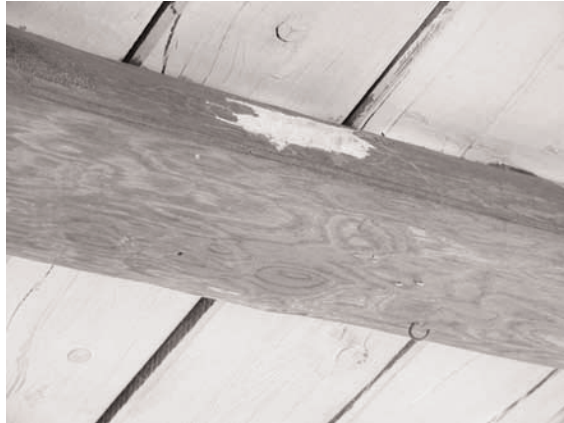
**Fig. 7.**  
*Insect damage on a porch beam, as evidenced by the yellow frass from powder post beetles.*

With decay, there is a definite progression from sound wood to punky wood to a total loss of wood fiber, i.e., a void. Unlike decay, insect damage tends to have an abrupt transition between affected and unaffected areas of the wood. Wood that has not been penetrated by insects retains its structural integrity, although there can be a loss of cross section. The loss of cross section directly relates to the load-carrying capacity of the member by reducing the volume of wood available to carry loads. The reduction in cross section, if known, can be taken into account by engineers to determine whether the affected member can still carry the required loads or needs to be reinforced or replaced. For both types of deterioration, moisture is generally required, and the result is a loss of integrity of the wood member, as well as a loss of cross section (Fig. 7).

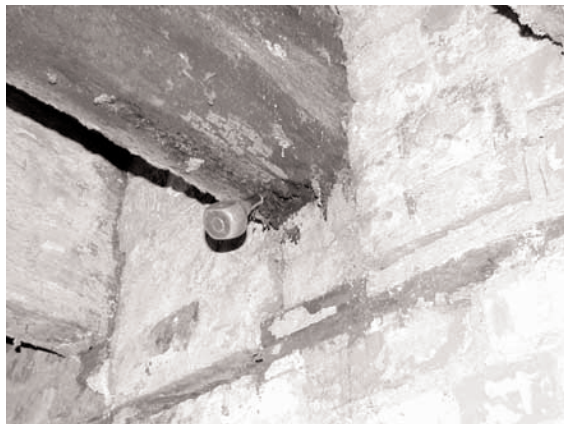
**Fig. 8.**  
*Awl inserted to probe the interface between a timber beam and a masonry wall.*

Probing the wood with a sharp pick or an awl enables rapid detection of voids in the wood that may not be visible on the surface. Internal decay is often masked by the lack of evidence on the exposed surface of the wood. For advanced decay where large internal voids are present near the surface, probing can detect evidence of potentially serious deterioration. For internal voids in large timbers more advanced inspection methods are generally required to detect the void. Even for the early stage of decay, probing can reveal areas that have experienced sufficient deterioration due to decay fungi by allowing for easy entry of a sharp probe, although no void is yet present. Wood without incipient decay tends to offer more resistance to probing, due to its higher density and more intact internal wood structure (Fig. 8).

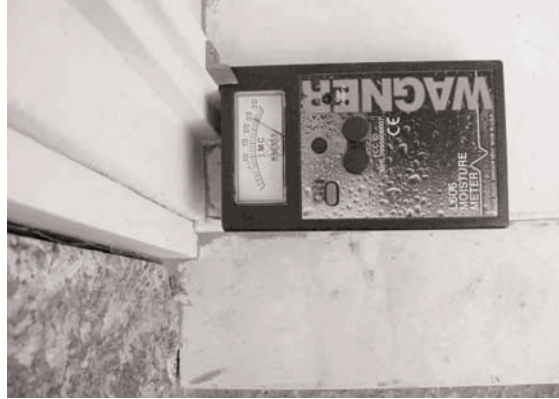
**Fig. 9.**  
*Capacitance-type moisture meter being used on window sill.*

Capacitance-type meters measure the electrical field within a small area of a piece of wood (Fig. 9). They do not require penetration of probes into the wood and generally provide the average moisture content throughout a certain depth, typically less than an inch; however, a wet surface (e.g., rain on a window sill) can dramatically affect the reading. These meters are particularly useful for measuring the moisture content of interior and exterior woodwork (doors, windows, trim, etc.) and dimension lumber.

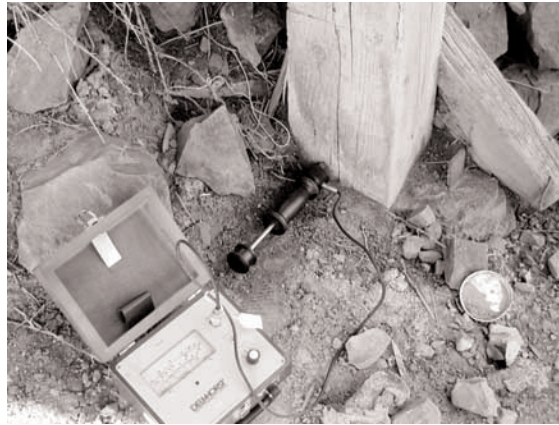
**Fig. 10.**  
*Conductance-type moisture meter being used on a timber column in contact with the ground.*

meter, will provide a better indication of the internal moisture content. A conductance-type meter conducts electric current through wood between two probes (Fig. 10). The probes, which come in different lengths, can be inserted into the wood to various depths, thus allowing for determining the moisture content at different depths of larger timbers. This technique is useful in determining whether wood is drying or taking up moisture.

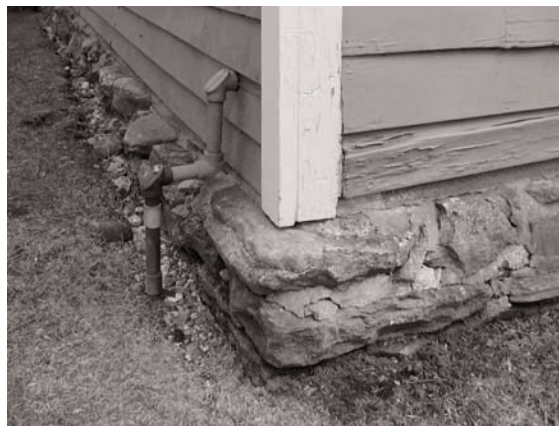
**Fig. 11.**  
*Timber sill and wood cladding in contact with stone foundation.*

- material interfaces, such as wood and masonry, particularly beam pockets (Fig. 11)
- exterior woodwork, including cladding, shingles, and soffits
- porches
- crawl spaces and basements
- areas of the structure that have been altered
